FINAL REPORT OF COAL-MINE BUMP ACCIDENT

NO. 2 MINE

UNITED STATES STEEL CORPORATION, COAL OPERATING DIVISION
WILCOE, McDOWELL COUNTY, WEST VIRGINIA

January 31, 1966

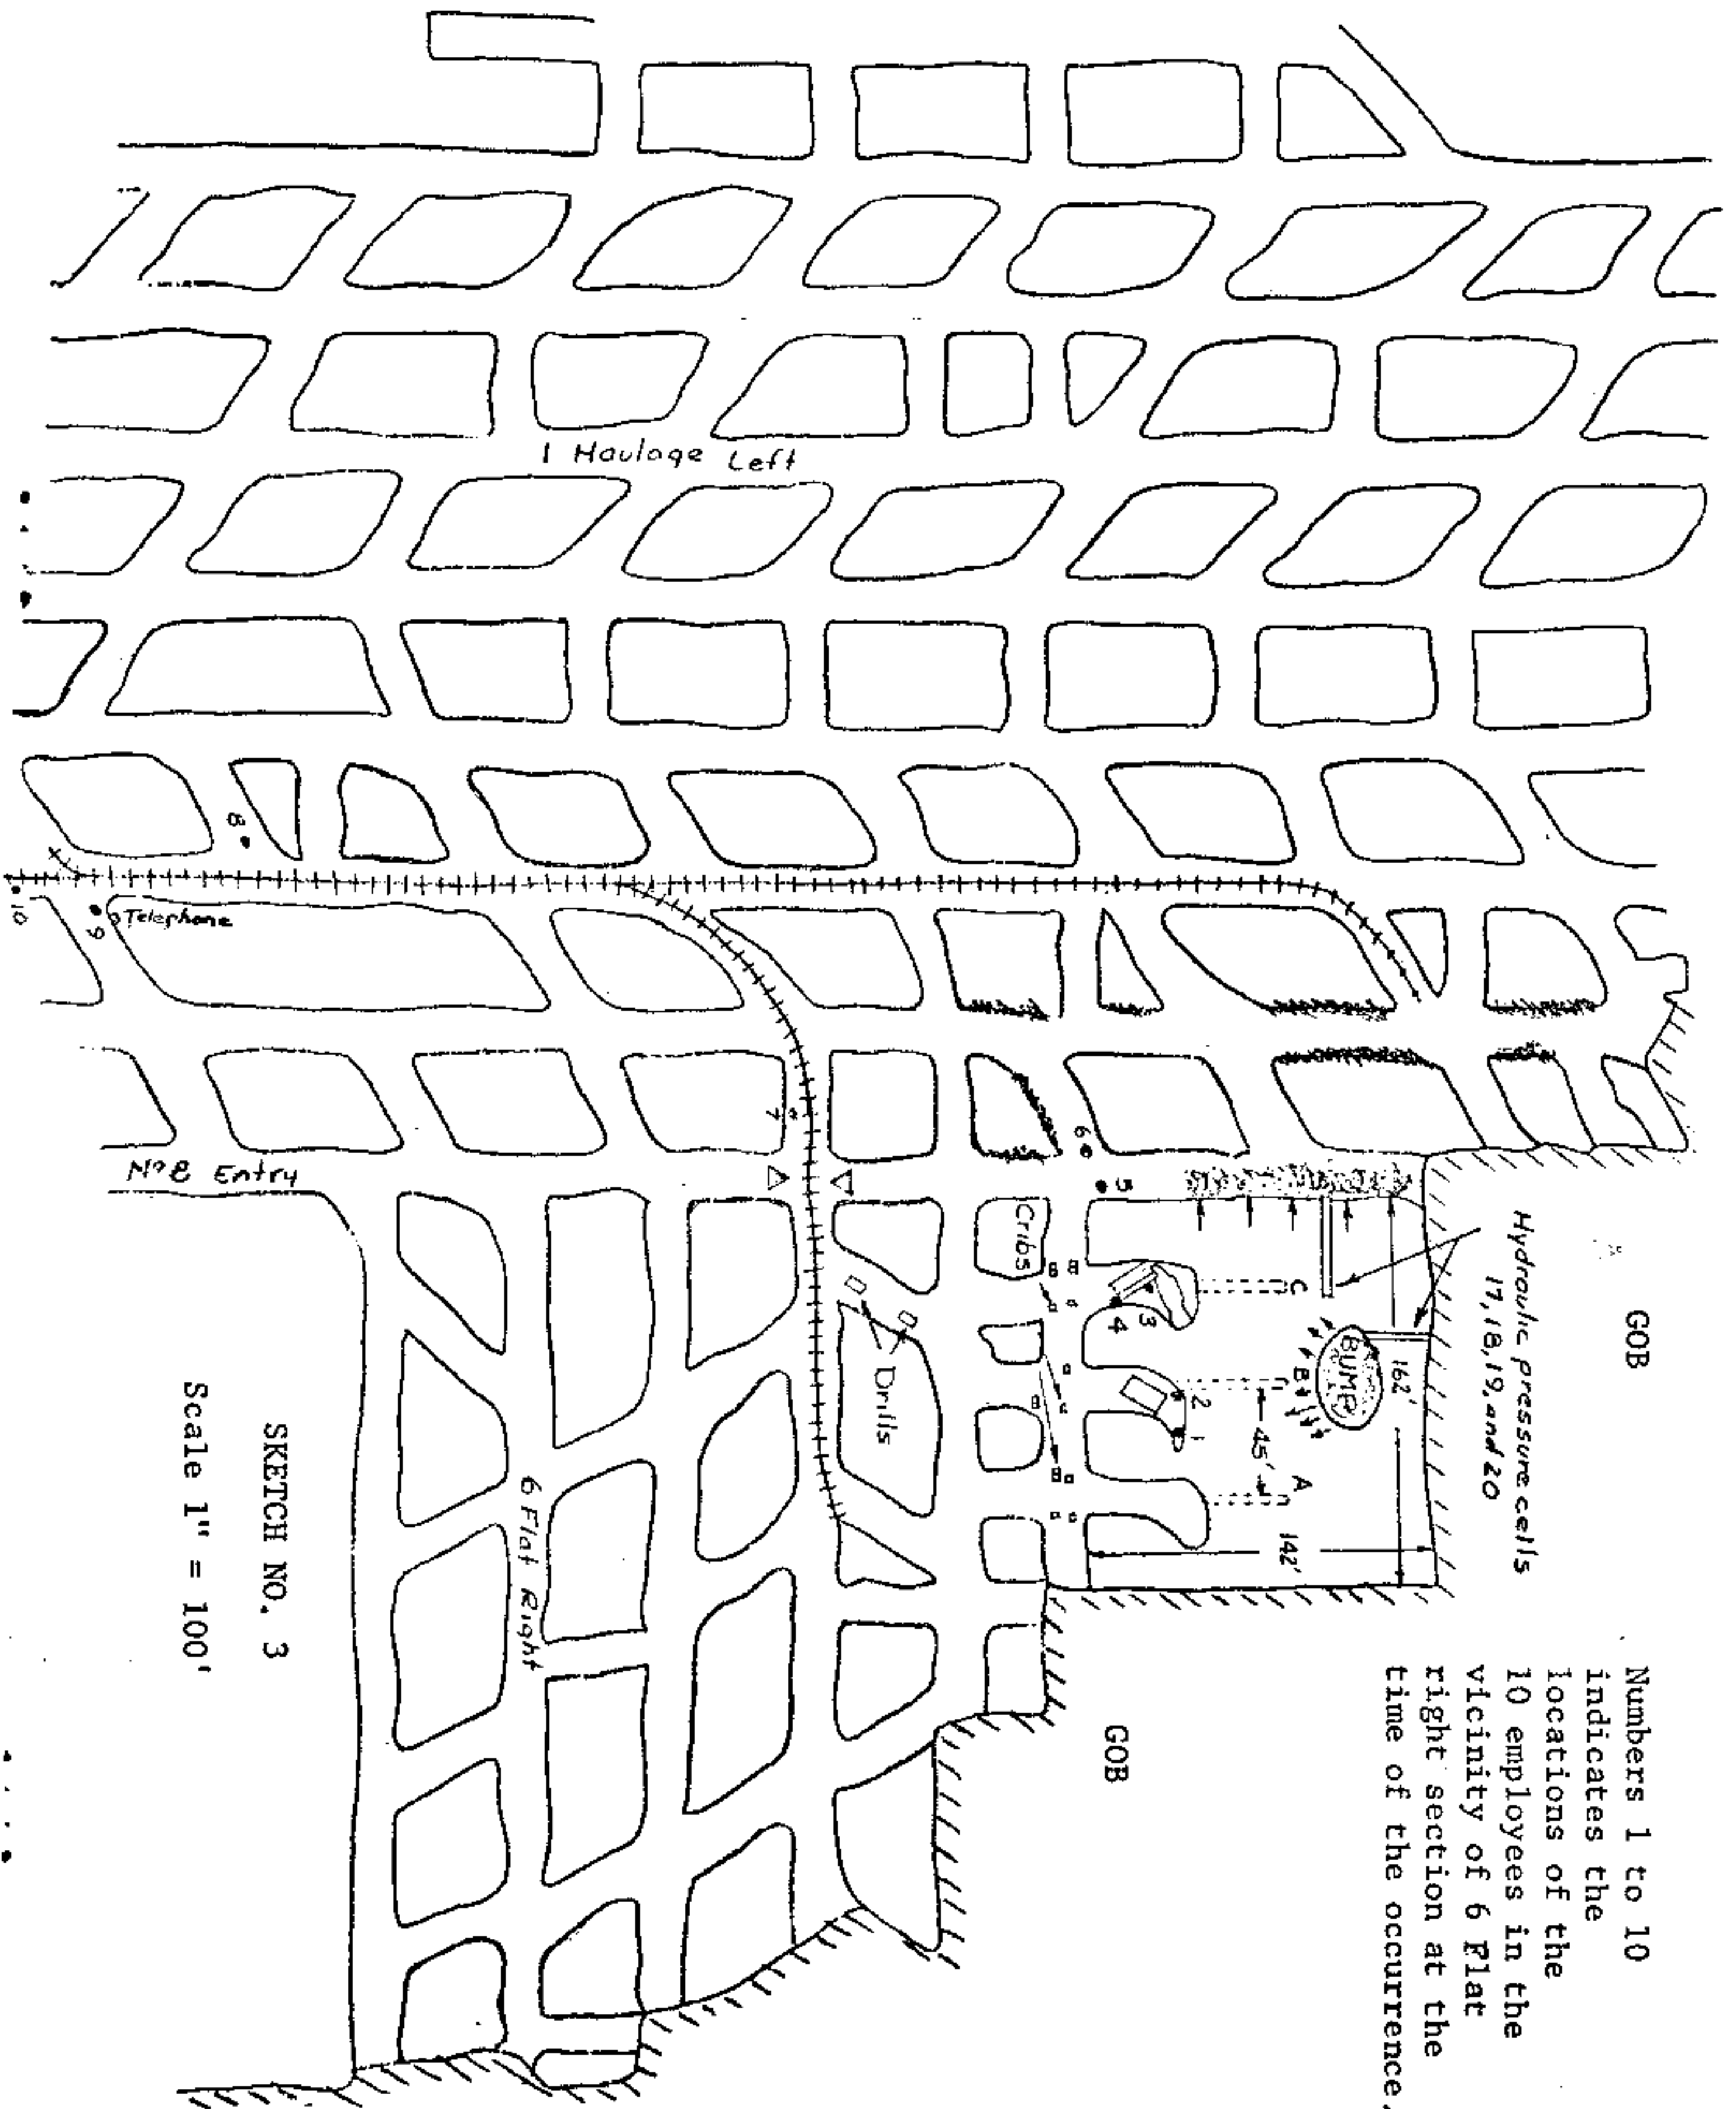
The location of the men and equipment and the extent of augering and secondary mining in the 6 flat right "bump block" are indicated in detail in Sketch 2. The active area of 6 flat right and the extent of extraction in the 1 haulage left section when the coal outburst occurred are indicated in Sketch 3.

The outburst was violent in nature, in that large amounts of coal were expelled violently from the immediate face areas of the A, B, and C places, and coal was also shaken from one or more ribs of 6 adjacent pillars, as indicated in Sketch 3. The roof was affected (cracks) to minor extent in each of the working places and slight localized floor upheaval was noted.

The continuous miner operator was thrown from the deck of the miner to a position between the miner and shuttle car in C room, as indicated in Sketch 2, when this equipment was thrust outward about 6 feet from its original operating position prior to the outburst. McKaughan, shuttle car operator, was thrown from the deck of the shuttle car but was uninjured.

Numbers 1 to 10 indicates the locations of the 10 employees in the vicinity of 6 Flat right section at the time of the occurrence.
